Geology Technical Report

*For the C-470 Corridor
Revised Environmental Assessment*

January 2015

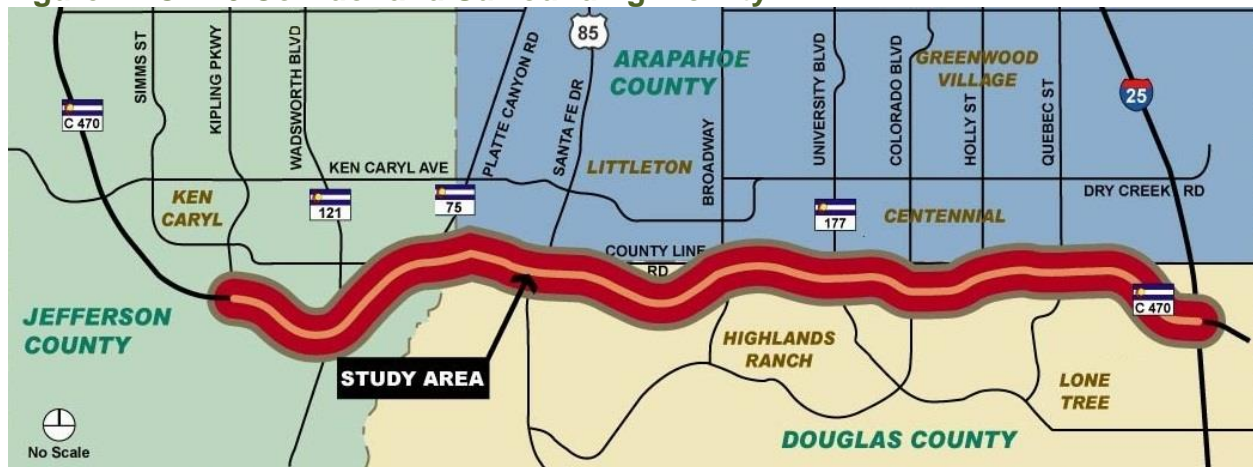
Figure 1. C-470 Corridor and Surrounding Vicinity

C-470 is located about 13 miles south of downtown Denver. It passes through Arapahoe, Douglas, and Jefferson counties, as shown in Figure 1. CDOT and FHWA prepared the Revised EA for the 13.75-mile portion of C-470 between Kipling Parkway and Interstate 25 (I-25) to address congestion and delay, and to improve travel time reliability for C-470 users.
